Effects of high temperatures on different dental restorative systems: Experimental study to aid identification processes

This “*in vitro*” study was to observe the effects of high temperatures on teeth restored by (1) amalgam overlaying glass ionomer bases, (2) composite/adhesive system overlaying glass ionomer bases, (3) ZnO modified temporary filling material vs. unrestored teeth. Fifty un-restored teeth (control group), 50 teeth with class I amalgam restorations and glass ionomer bases, 50 teeth with class I composite/adhesive system restorations and glass ionomer bases and 50 teeth with class I ZnO modified temporary filling material restorations were placed in a furnace and heated at a rate of 10°C/min. The effects of the predetermined 200, 400, 600, 800, 1000 and 1200°C temperatures were examined macroscopically and then observed microscopically by means of a stereomicroscope. Our observations showed that the class I restorations made of amalgam on glass ionomer bases as far as the class I restorations made of ZnO modified temporary filling material can be identified till 1200°C because they maintain their shape despite the disintegration of the crowns, whilst the class I co

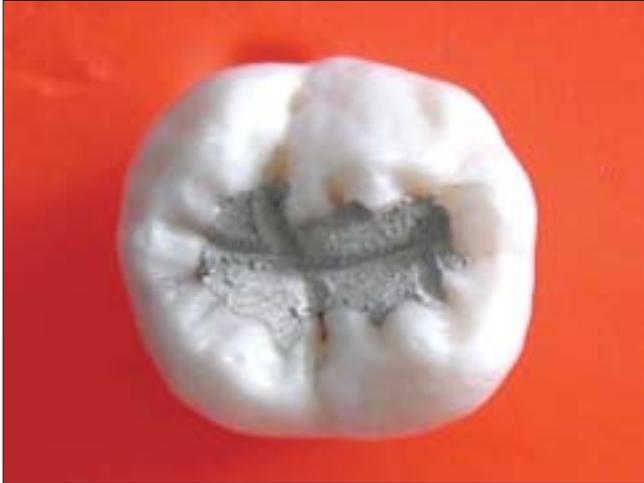
Figure 1: Restored teeth with amalgam filling subjected to 200°C. Amalgam showed an alteration of the marginal seal, loss of brightness and small bubbles on the surface

At 200°C and at 400°C the amalgam showed an alteration of the marginal seal, loss of brightness and bubbles on the surface [Figures 1 and 5]. At 600°C the amalgam showed an opaque black color and an increased alteration of the marginal seal. At 800°C the amalgam showed a corrugated surface with fissures between amalgam and dental tissues [Figure 6]. At 1000°C there were some cracks in the black filling amalgam [Figure 7]. At 1200°C a fragmentation of the crown in more than half of the samples was observed. The black colored amalgam presented fractures and cracks.

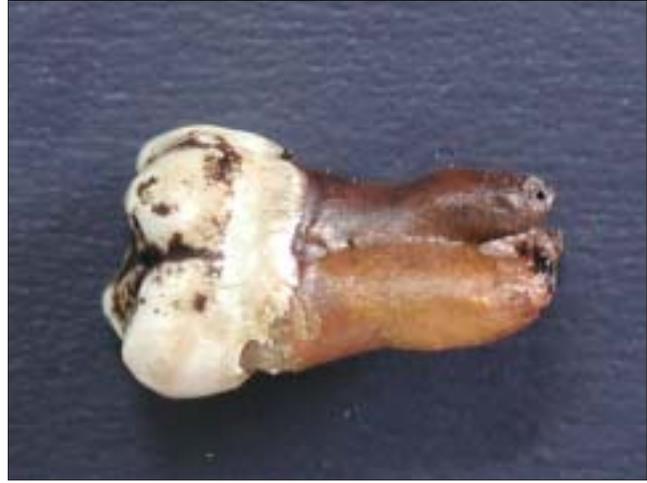
Figure 2: Un-restored teeth subjected to 400°C. Enamel fissures in the cervical area and dark brown color of the cement

At 200°C there is a loss of brightness on the enamel and cement; on the crown some parts showed a slight brownish color and some cusps turn white [Figure 1]. At 400°C the crown showed a darkest tonality, enamel fissures particularly in the cervical area, and the cement acquired a brown color [Figure 2]. At 600°C the crown presented a dark brown color with black stains, separation of the enamel-dentine interface at the level of the cervical margin, longitudinal cracks of the enamel and the cement; at the root level can be observed longitudinal cracks and a brown color of the cement. At 800°C the crown was gray with the cusps colored white, the cement showed a blue-gray color [Figure 3]. At 1000°C in some teeth there was a fragmentation of the enamel, the dentine showed a white color with blue-gray stains, and the cement turned to a chalky white color with cracks [Figure 4]. At 1200°C the enamel and the dentine were fragmented in most of the samples and longitudinal and transversal cracks of the root were observed. In some teeth exposition of the pulp chamber was observed, allowing the identification of changes like pulp calcinations and inner transversal cracks of the dentine continuing in the root.

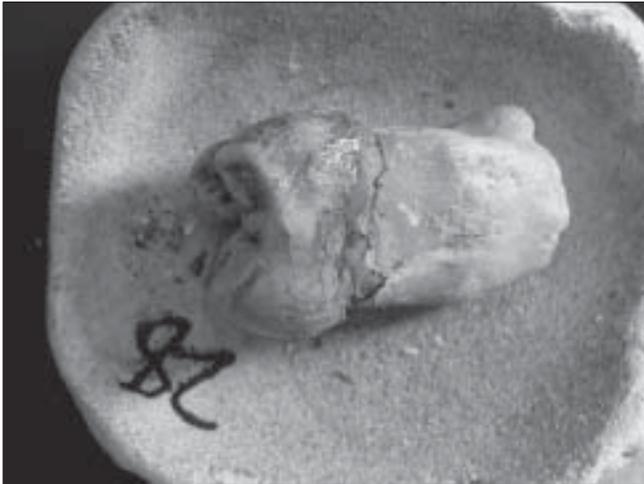
Figure 3: Un-restored teeth subjected to 800°C. Separation of the enamel in the cervical area. Fissures of the cement which show a blue-gray colour

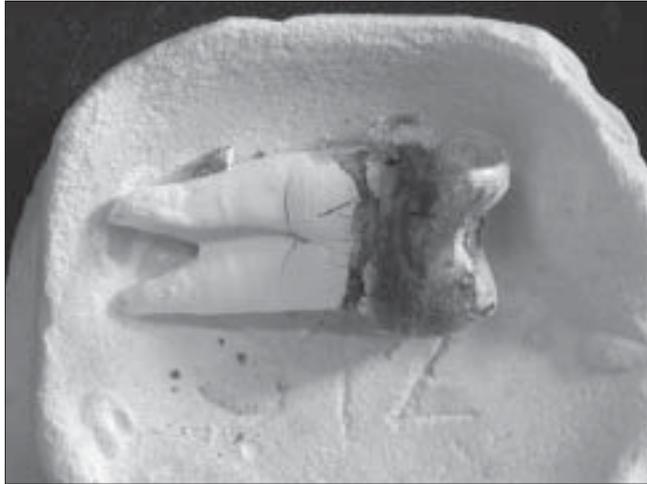
Figure 4: Un-restored teeth subjected to 1000°C. 1. Separation of the enamel in the cervical area and cracks of the enamel and root

In all the unrestored teeth, fissures were observed in the enamel starting from 400°C, which turned in cracks at 600°C as it was described by Gunther and Schmidt^[11] and by Nossintchoux. -quoted by Moya *et al.*^[1] as far as the crown remains at 1200°C [Figure 4]. The enamel fragmentation is described starting at 600°C and its disintegration in some teeth at 1200°C. In the tooth's cement we observed fissures at 400°C and cracks starting from 600°C until 1200°C; furthermore, we observed longitudinal cracks that continue to the root dentine and cause in some specimens fragmentation of the roots, which coincides with the description by Merlati *et al.*^[10] and that in many cases caused root fracture lines. But, Nossintchoux described root fissures and cracking of the roots starting from 175°C.^[1]

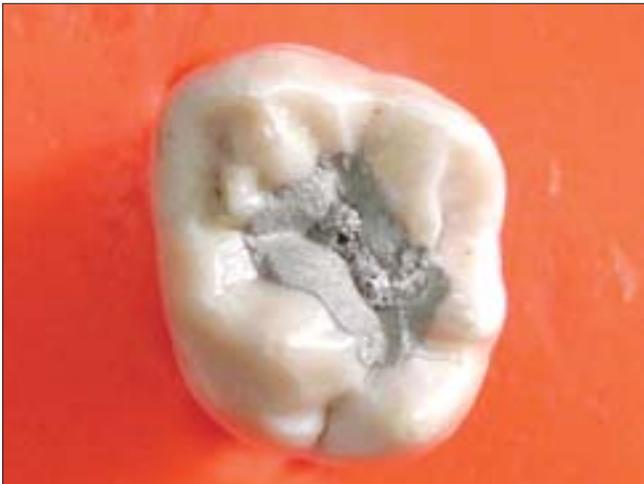
Figure 5: Restored teeth with amalgam filling subjected to 400°C. Bubbles in amalgam, marginal contraction of amalgam and fissures of the enamel

Concerning the fillings surface, between 200°C and 400°C, the amalgam showed a corrugated or blistered surface in all of the teeth, which was due to the apparition of small nodules by alloy dissociation [Figure 5], where the mercury evaporated through gaseous bubbles, which form blisters or nodules when temperature decreases. This condition is also reported by Merlati *et al.*, at 200°C.^[10] It is important to mention that the nodules vary their size when the temperature increases until the mercury evaporates completely from the alloy in an boiling rank that goes from 39°C up to 360°C;^[1] from then on the evaporated mercury drags silver particles, that from 800°C confirm what Gunther and Schmidt. called "silver bullets"^[11] [Figure 7]. The composite fillings turned corrugated when temperature increases until they incinerated at 1000°C [Figure 10]. The modified zinc oxide turned also corrugated [Figures 12 and 13].

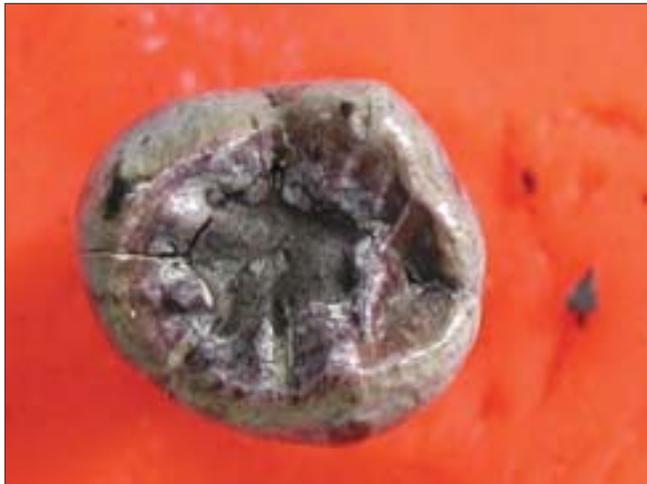
Figure 6: Restored teeth with amalgam filling subjected to 800°C. Contraction and cracks in amalgam filling

In relation to the dental restorations, the amalgam at 200°C and 400°C lost its shine due to the mercury evaporation^[10] and showed an opaque black color from 600°C [Figure 6].

oxides at 450°C.^[29,30] Another important feature referring to color in amalgam restored teeth is the formation of a golden thread that surrounds the occlusal surface and the cusps between 800°C and 1200°C [Figure 6]; we supposed that this phenomenon was associated to mercury oxide vapors in reddish and yellowish tones or copper oxides and silver oxides from the 962°C.^[29-31]

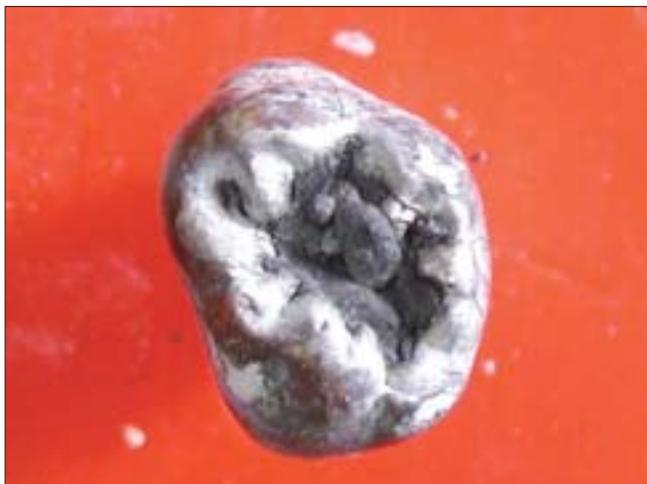
Figure 7: Restored teeth with amalgam filling subjected to 1000°C. Cracks of the enamel. Silver bullets and contraction in amalgam filling

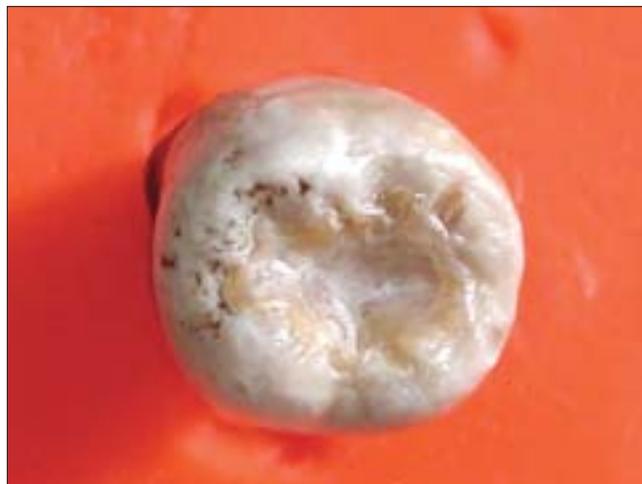
Figure 8: Restored teeth with composite filling subjected to 400°C. Composite bright brown color with white pigments

At 200°C the composite filling showed marginal retraction and brown color. At 400°C there was an increase in the marginal retraction [Figure 8]. At 600°C the color of the composite turned black-grayish, some cracks appeared and a dislodgement of the obturation in some teeth occurred [Figure 9]. At 800°C the composite showed a chalky white color; in most of the samples there was a dislodgement of the fillings and exposition of the glass ionomer bases, which showed a black color, with cracks and marginal retraction [Figure 10]. At 1000°C the crown acquires a dark gray color; in a half of the samples, enamel pulverization and root fracture occurred, so the exposed dentine is white with gray-bluish stains. At 1200°C the crown changes to a white-

The composite restorations turned to a bright brown color with white veins at 400°C [Figure 8], as described by Merlati *et al.*, like yellowish brown^[24] and then increased its shine. At 600°C the resin changed to a grayish black color (given by gray veins) [Figure 9], due to the acrylic matrix combustion, according to Merlati *et al.*,^[10] then, a white chalk color [Figure 10] was observed starting from 800°C up to 1200°C.

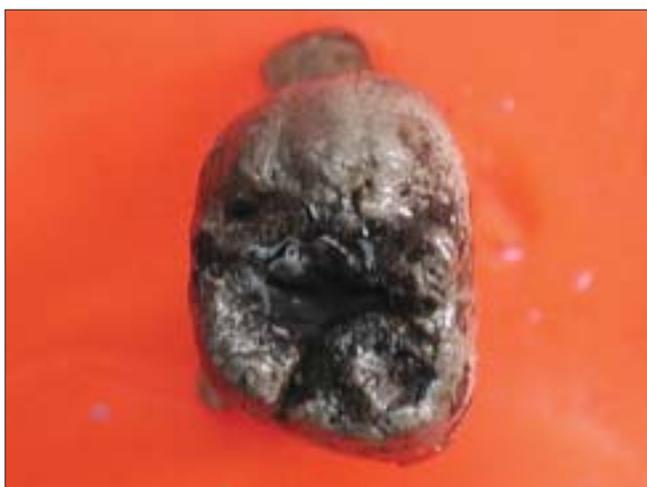
Figure 9: Restored teeth with composite filling subjected to 600°C. Cracks of the enamel. Marginal contraction (gaps between enamel and composite) and composite black colour with gray pigments

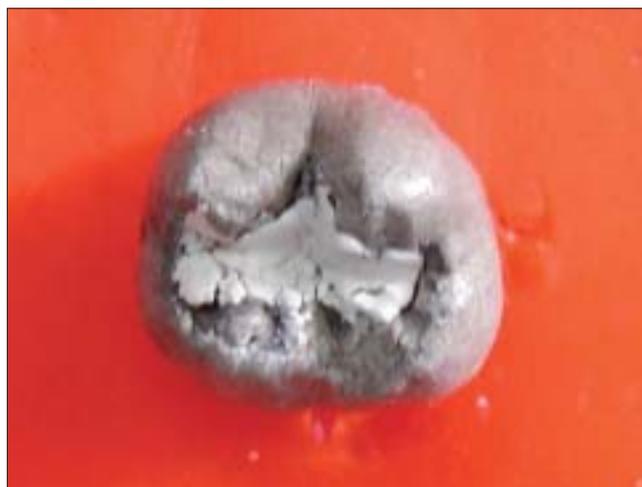
Figure 10: Restored teeth with composite filling subjected to 800°C. Marginal contraction and incinerated composite with cracks and white color

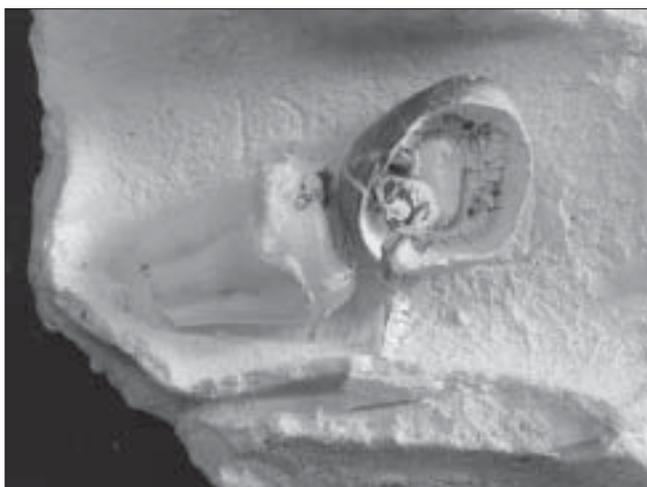
Figure 11: Restored teeth with composite filling subjected to 1200°C. Incinerated composite filling. Cracks of the enamel and the root. See separation of the enamel in form of a skullcap

grayish color and in most of the sample a dislodgement of the filling occurred [Figure 11].

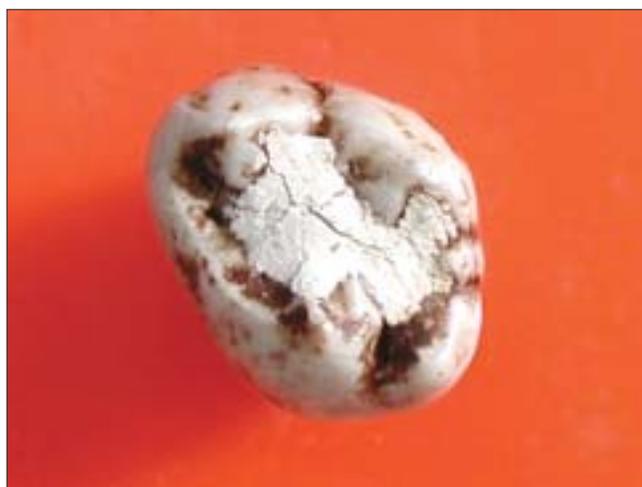
Figure 12: Restored teeth with zinc oxide modified cement subjected to 400°C. Fissures in the filling

At 200°C the teeth showed cracks on the surface and dimensional expansion of the ZnO modified temporary fillings for water evaporation, growth of crystals and air capture. At 400°C a break of the cervical enamel occurred; then, we observed longitudinal fissures on the enamel, and brown color of the fillings [Figure 12]. At 600°C the zinc oxide cement was dark gray with cracks and dimensional contraction by several losses of water, fracture of some crystals and agglomerated particles of zinc. At 800°C the material was chalky white and one third of the samples showed a dislodgement of the fillings. At 1000°C the temporary cement showed a white chalk color and cracks, but in the large amount of the samples a dislodgement of the fillings occurred. At 1200°C samples fragmentation of enamel and dentine, and transversal cracks on the root occurred [Figure 13].

Finally, the ZnO modified cement changed its color at 600°C, turning dark gray, and being more dazzling at 1000°C [Figures 12 and 13], such as referred by Gunther and Schmidt.^[11]

At 200°C the amalgams and composite fillings showed a marginal contraction probably due to the evaporation of the mercury and loss of the organic matrix, as it was described by Moya *et al.* and Merlati *et al.*^[1,10] At 400°C all the permanent restorative systems showed a marginal contraction, while the ZnO modified cement showed an expansion. In the amalgam fillings, cracks were observed since 600°C, and starting from 800°C the cracks become macroscopically visible until 1200°C. Some specimens showed fractures of the fillings starting from 600°C and dislodgment of it since the 1000°C, similar to Merlati *et al.*^[24] As for the resin, they observed cracks starting from 600°C and up to 1200°C. Some specimens showed dislodgment of the fillings since the 600°C and fractures at 1000°C. The ZnO modified cement showed cracks starting from 200°C, dislodgment since 800°C and fractures at 1000°C [Figure 12].

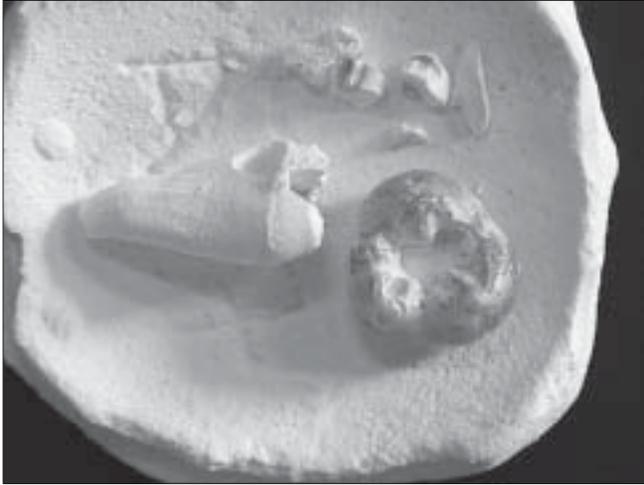
Figure 13: Teeth restored with zinc oxide modified cement subjected to 1200°C. Filling dislodgment. See dentine remain and occlusal cavity
